Corrosion Report

Equipment Location ID 0955-036-A03
Equip. Location Descrip. NO. 4 SC FLUSH OIL TO C-1100

08/19/2009 MHEE	INSPECTION PIPING ISOMETRIC		
	#36 FLUSH OIL		
	#4 CRUDE UNIT (PLANT 11)		
	DISTILLATION AND REFORMING AREA BUSINESS UNIT		
Z	0955-036-A03	REV	SHT
		1	1

History Brief

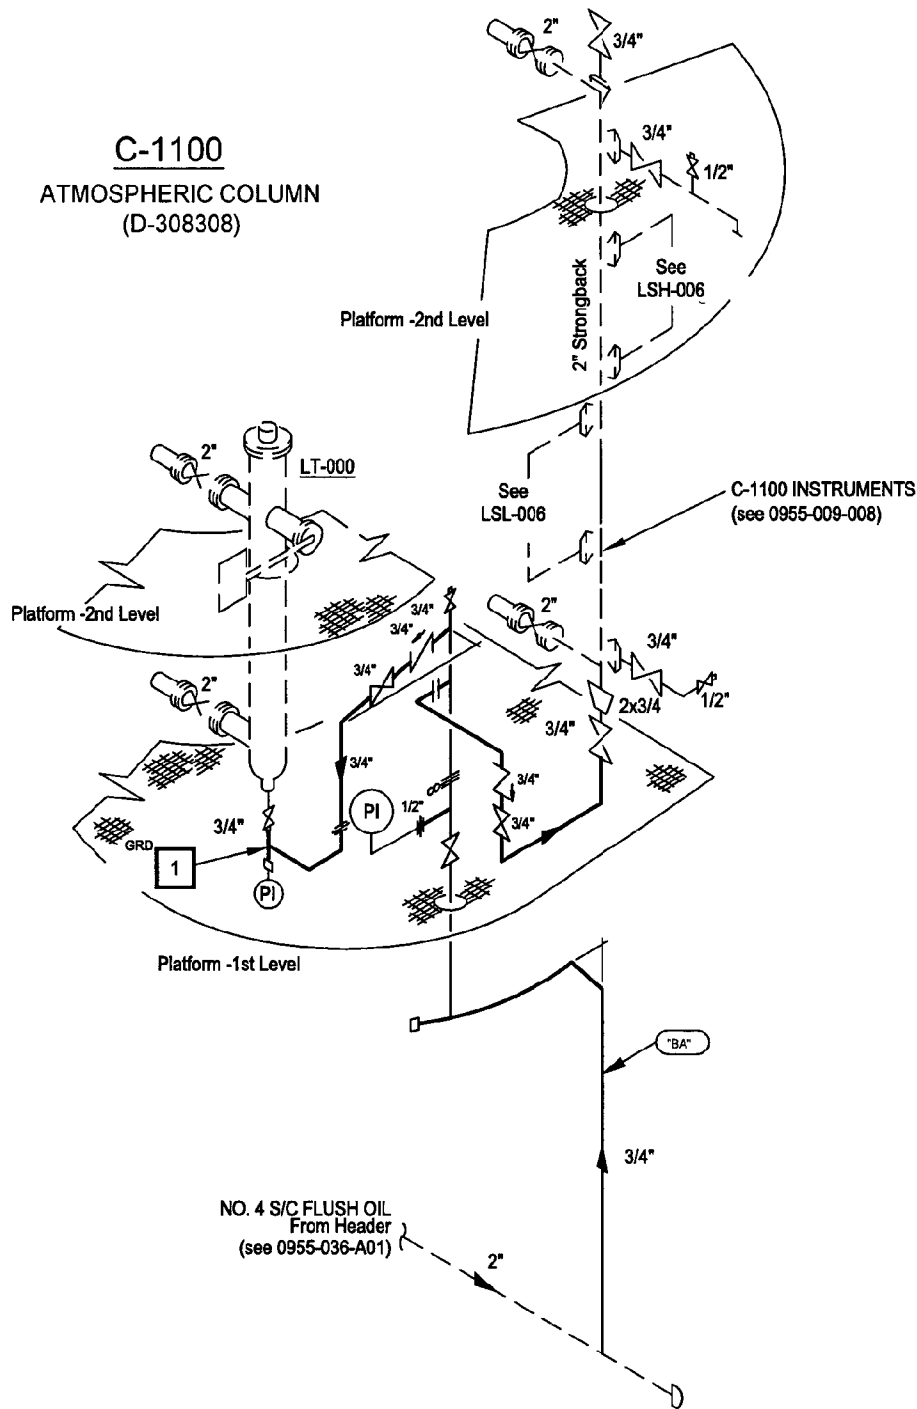
NO. 4 S/C FLUSH OIL TO C-1100

DP ID	MEAS METH	DP STAT	DP SZ	DT TYPE	BASE	MEAS 5	MEAS 4	MEAS 3	NEAR	LAST	MIN VALUE	CCR	REM LIFE
001.R	RT	A	0.75	ELL	0.310 01/08						0.100	5.00	42.00

This line was located in fire zone 4. Inspection consisted of the following:

1. Visual inspection of the line in the overhead pipeway above the P-1105's. The insulation and jacket were damaged. The pipe was not deformed. Hardness tests were taken with a range of 168-192BHN.
2. Repairs included replacement of the damaged insulation and jacket.
